INVESTIGATION OF EXPERIMENTAL LIGHTWEIGHT FIREWALL MATERIALS FOR A/C ENGINE BAY APPLICATIONS

Jeffrey Moyer, First Lieutenant, USAF Fire Protection Branch Fuels and Lubrication Division

April 1985

Final Report for Period 1 October 1983 - 2 May 1984

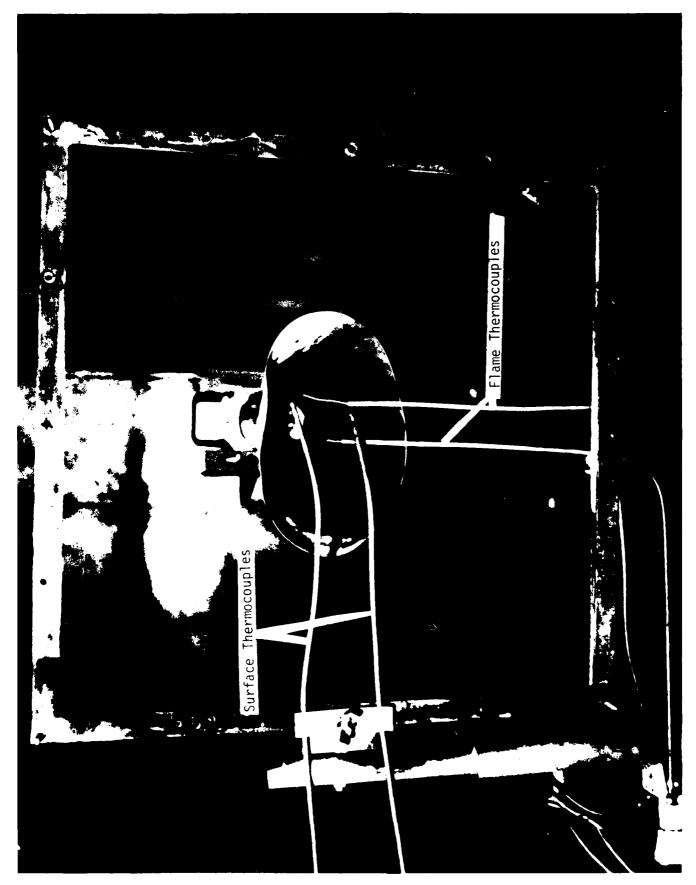
Figure 3. Fire Penetration Test Set-Up Without Sample

Figure 2 shows the burner directed at the thermocouple rake used to characterize the flame. Figure 3 shows a test set-up (minus the sample). You can clearly see the thermocouples used to measure flame and surface temperature. Finally, Figure 4 is a picture of the instrumentation panel used to monitor and control the tests.

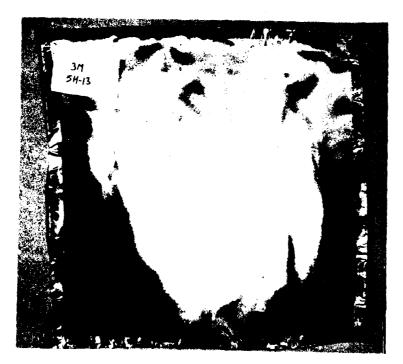
Figure B-8. Nextel  $^{\rm R}$  5H-13 Fabric Without Aluminum Back After Fire Penetration Test

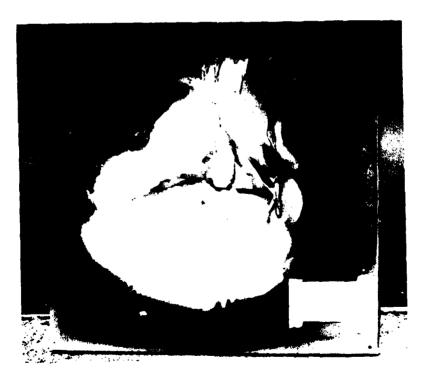
Figure B-36. CG #4530-4 After Fire Penetration Test

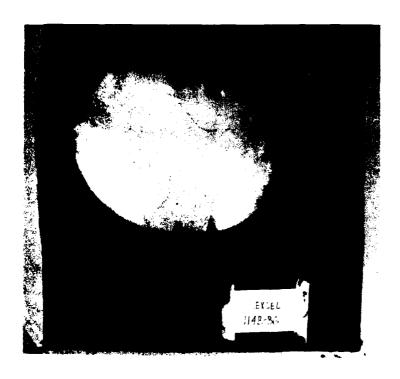
Figure B-48. F-174 Polyimide Resin Composite Firewall 114B-86 After Fire Penetration Test

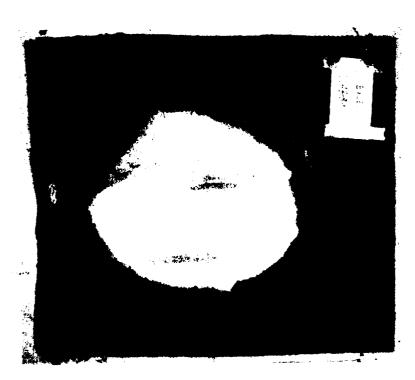
Figure B-54. F-178 BMI Resin Composite Firewall 114B-89 with Honeycomb Core After Fire Penetration Test
